**A MARKET  
AND DESIGN  
STUDY  
FOR THE  
BROADWAY**

**NATIONAL REGISTER HISTORIC DISTRICT**

**NASHVILLE, TENNESSEE**

# Architectural Guidelines

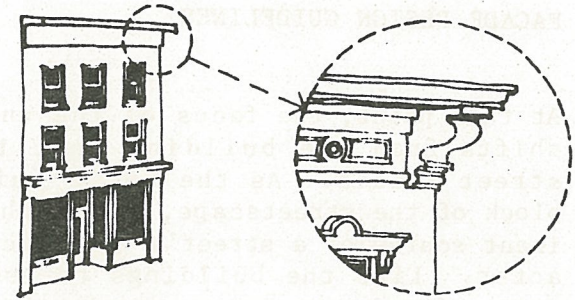
### 1 FACADE MATERIALS

ALL EXISTING HISTORIC MATERIALS, BOTH APPLIED DECORATION AND SURFACE TREATMENTS, SHOULD BE AUTHENTICALLY RESTORED.

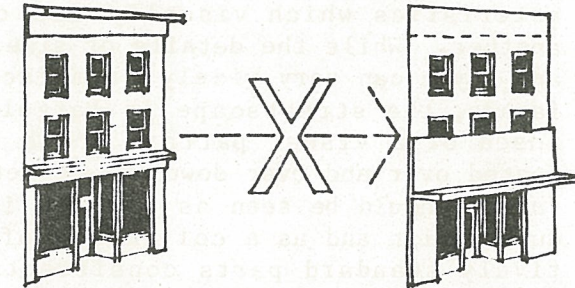
### 2 FACADE SURFACES

EXISTING FACADE SURFACES OF HISTORIC OR ARCHITECTURAL SIGNIFICANCE SHOULD NEVER BE COVERED OVER WITH A NEW FACADE MATERIAL.

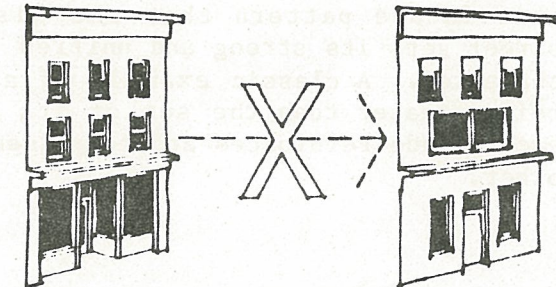
### 3 WINDOW CONFIGURATION

THE EXISTING ORIGINAL CONFIGURATION OF UPPER FACADE WINDOWS AND THE STOREFRONT OPENING SHOULD NEVER BE ALTERED.

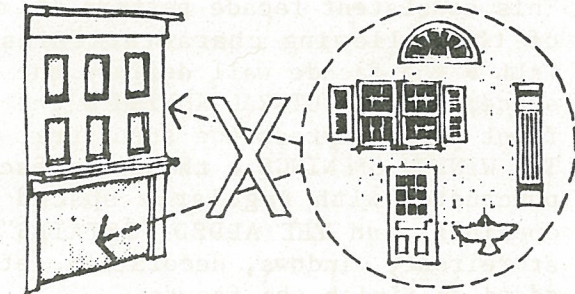
### 4 "FAKE HISTORY"

NEW DESIGN SHOULD NOT ATTEMPT TO DUPLICATE HISTORIC DETAIL; THIS DRAWS ATTENTION AWAY FROM THAT WHICH IS AUTHENTIC.

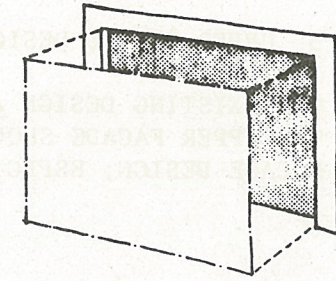
### 1 THE STOREFRONT OPENING

THE STOREFRONT SHOULD ALWAYS BE RECESSED INTO THE FACADE'S STOREFRONT OPENING. IT SHOULD NEVER BE APPLIED TO THE FACE OF THE FACADE.

THE STOREFRONT CONSTRUCTION SHOULD BE RECESSED 6" TO 12" INSIDE STOREFRONT OPENING.

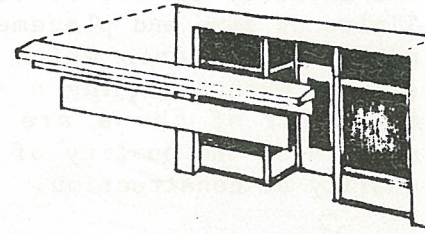
5 THE STOREFRONT CORNICE

THE STOREFRONT CORNICE SHOULD HAVE A STRONG HORIZONTAL FORM AT ITS TOP TO SEPARATE IT FROM THE UPPER FACADE AND TO HELP CONTAIN COMMERCIAL SIGNAGE.

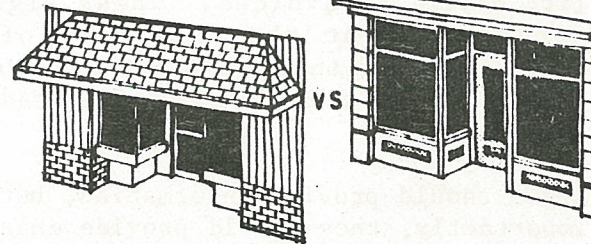
7 DESIGN SIMPLICITY

THE STOREFRONT DESIGN SHOULD BE FLEXIBLE, SIMPLE AND UNCLUTTERED IN ORDER TO EMPHASIZE THE DISPLAY WINDOWS.

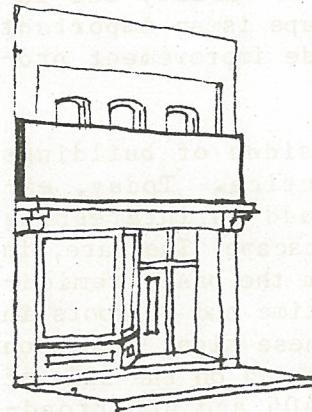
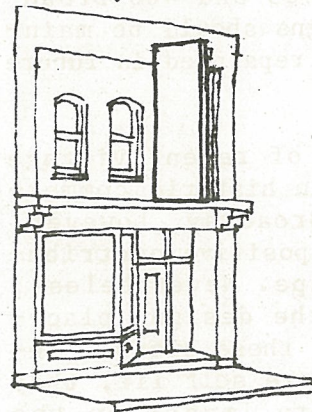
SIGNAGE SHOULD NEVER COVER UP IMPORTANT PARTS OF THE FACADE OR ATTRACTIVE DETAILS.

SIGNAGE SHOULD NOT BE SO LARGE THAT IT OVERWHELMS THE FACADE. ANY SIGNAGE THAT IS SELF LIT, SUCH AS NEON, SHOULD BE OF QUALITY DESIGN SO THAT IT CONTRIBUTES TO A POSITIVE IMAGE FOR THE STREET AS A WHOLE.

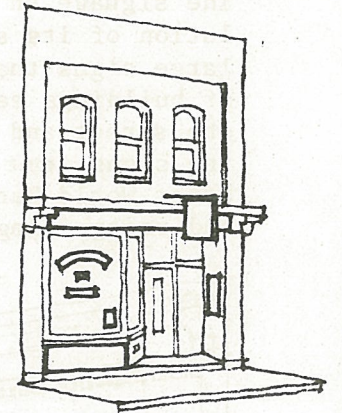
TOO MANY SIGNS ON A STOREFRONT DETRACT FROM THE APPEARANCE OF THE STOREFRONT AND ARE OFTEN CONFUSING.

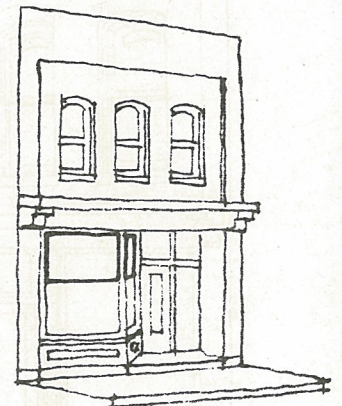
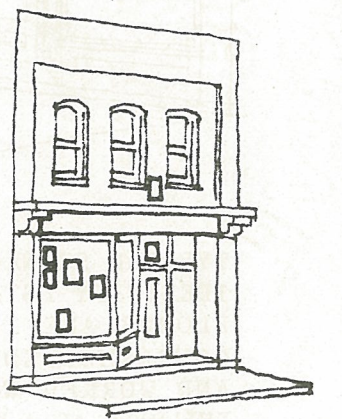
SIGNAGE SHOULD NOT REDUCE THE AREA OF THE STOREFRONT OR OF THE DISPLAY WINDOWS.

SIGNAGE SHOULD ALWAYS BE CAREFULLY PLACED. EVEN HAPHAZARDLY PLACED TEMPORARY SIGNS CONTRIBUTE TO A CLUTTERED IMAGE.

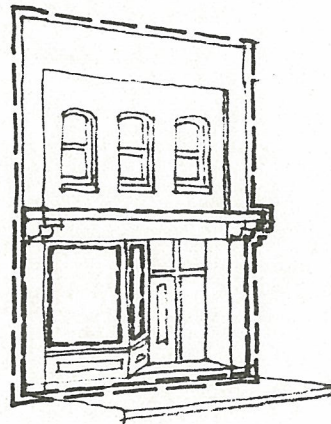
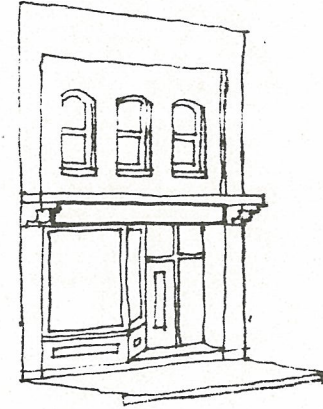
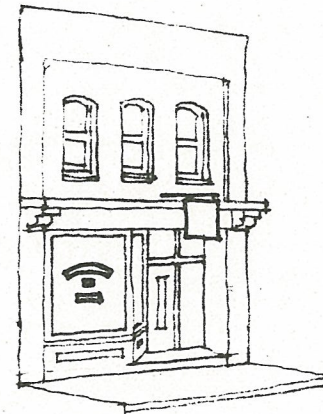
WHEN PLANNING SIGNAGE, THE FACADE AND STOREFRONT DISPLAYS SHOULD BE CONSIDERED PART OF THE OVERALL IMAGE.

SIGNS SHOULD ALWAYS FIT IT THE ARCHITECTURAL DESIGN OF THE FACADE. CAREFULLY ANALYZING THE FACADE DESIGN WILL REVEAL ALL THE OPTIONS FOR SIGNAGE.

WHEN MULTIPLE SIGNS ARE USED, EACH SIGN SHOULD BE SMALL AND RELATED IN DESIGN TO THE OTHERS. GENERALLY, A FACADE SHOULD HAVE NO MORE THAN THREE SEPARATE SIGNS.

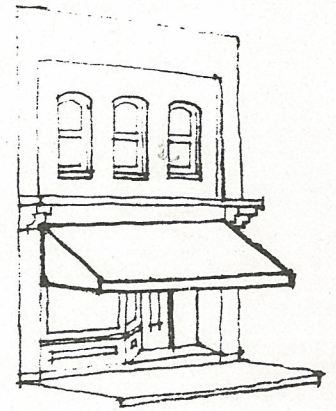
USE OF CANVAS AWNINGS PROVIDES AN ADDITIONAL OPPORTUNITY TO ADD SIGNAGE TO THE FACADE WHILE ADDING COLOR AND SHELTER FOR PEDESTRIANS.

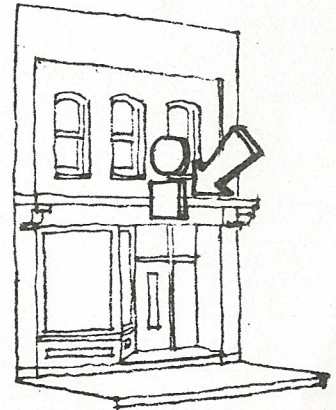
THE SCALE OF ALL SIGNAGE SHOULD RELATE TO THE SCALE OF THE BUILDING. THIS IS ESPECIALLY IMPORTANT FOR PROJECTING SIGNS. THE SIZE AND LOCATION OF PROJECTING SIGNS SHOULD BE CAREFULLY PLANNED TO AVOID COVERING ATTRACTIVE DETAILS AND DESTROYING THE OVERALL RHYTHM AND COMPOSITION OF THE FACADE.

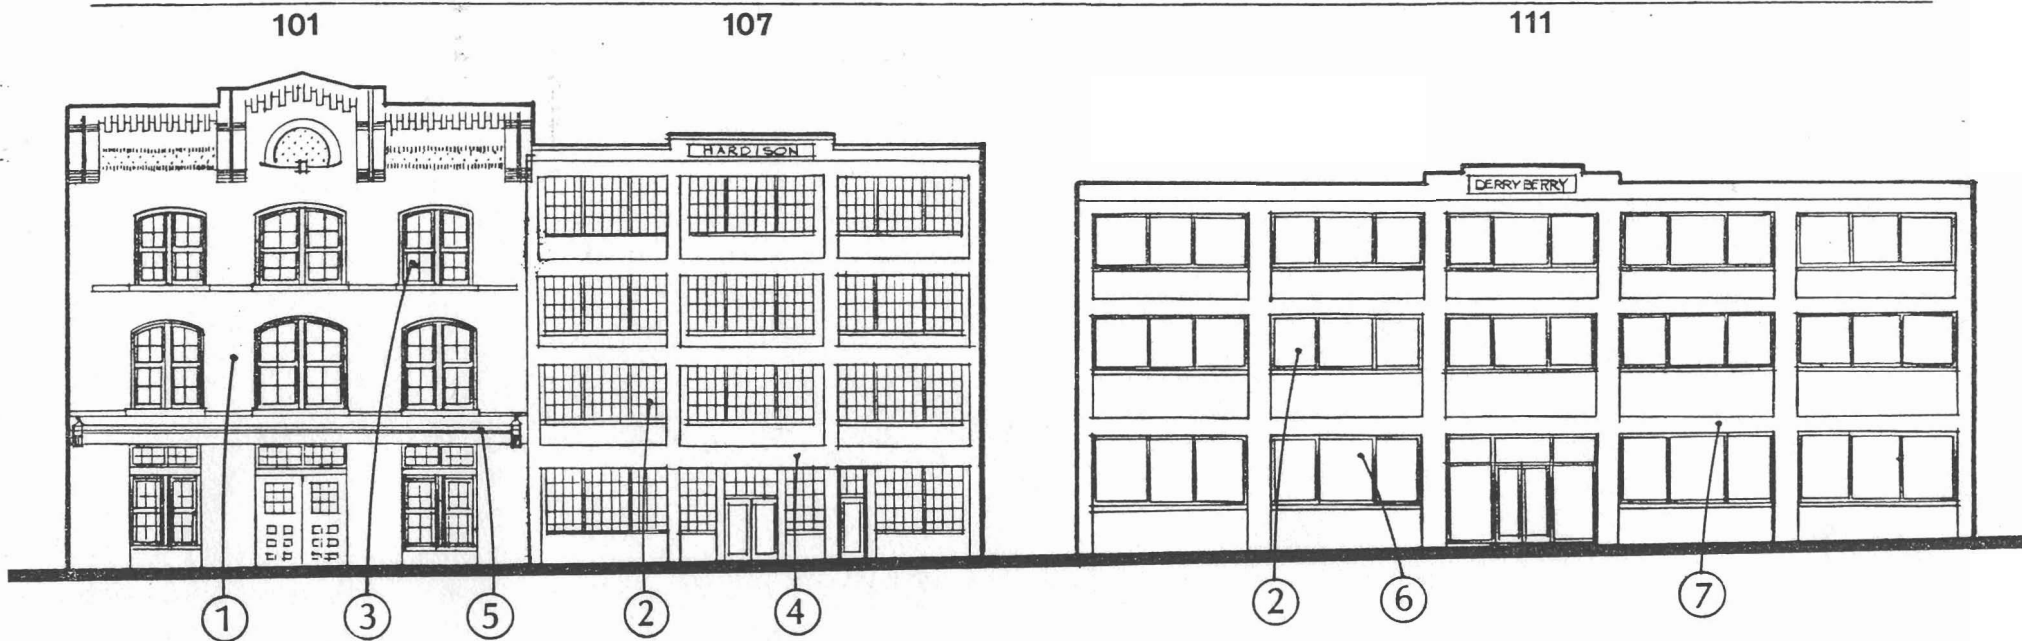
## 100 BLOCK, SOUTH SIDE

- ① Remove paint and repair brick wall as needed.

② Repair original windows or install compatible contemporary windows.
- ③ Restore or reconstruct facade windows.

④ Remove paint from concrete at storefront and clean entire facade.
- ⑤ Repair storefront cornice.

⑥ Install windows at first floor to match upper facade windows.

⑦ Repair damaged concrete and clean entire facade.

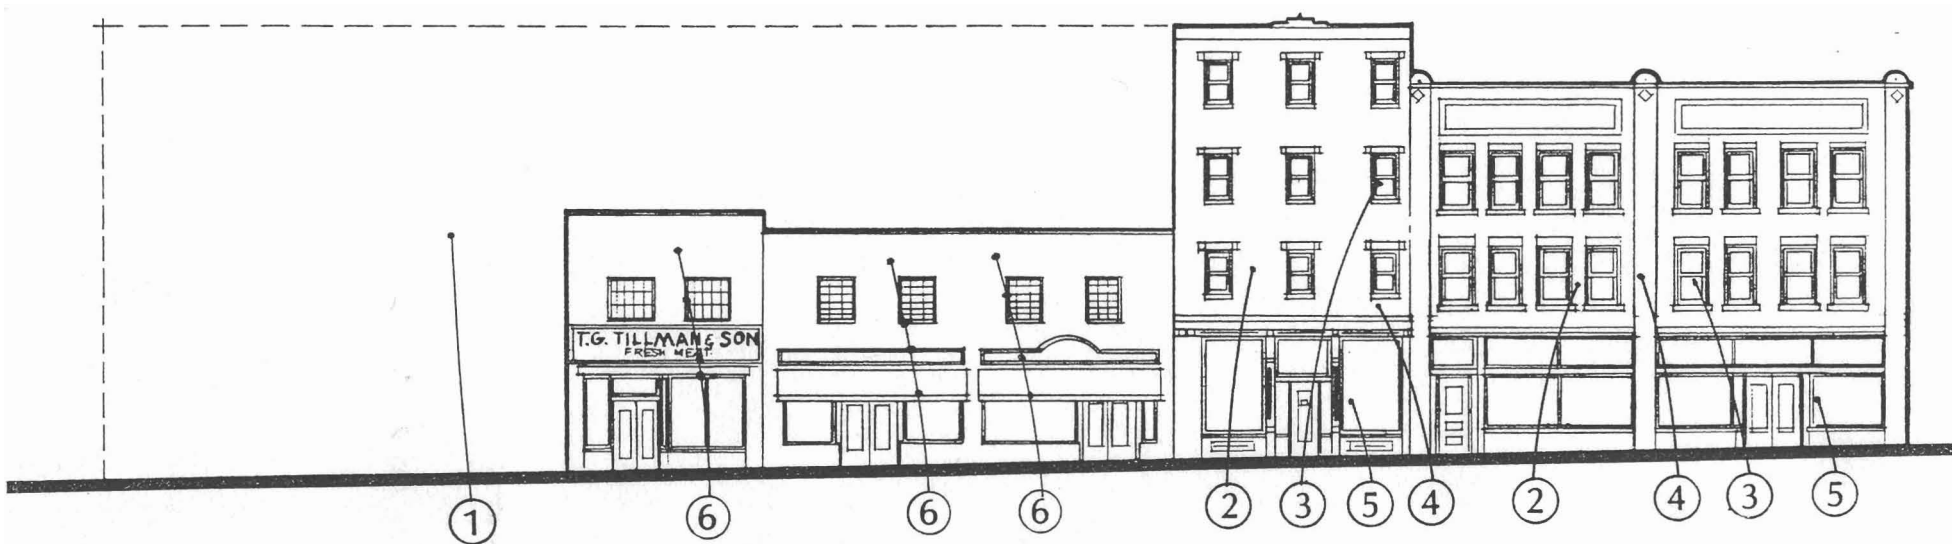
200 BL CK, SOUTH SIDE

| <p>① Construct new building compatible in design with adjacent historic buildings</p> | <p>② Remove false facade, restore original upper facade.</p> | <p>③ Restore upper facade windows.</p> | <p>⑤ Reconstruct historic storefront or install compatible contemporary storefront.</p> |
| | <p>④ Remove paint and restore brick as needed.</p> | <p>⑥ Clean and paint building, windows and sign, and install new canvas awning at storefront.</p> | |

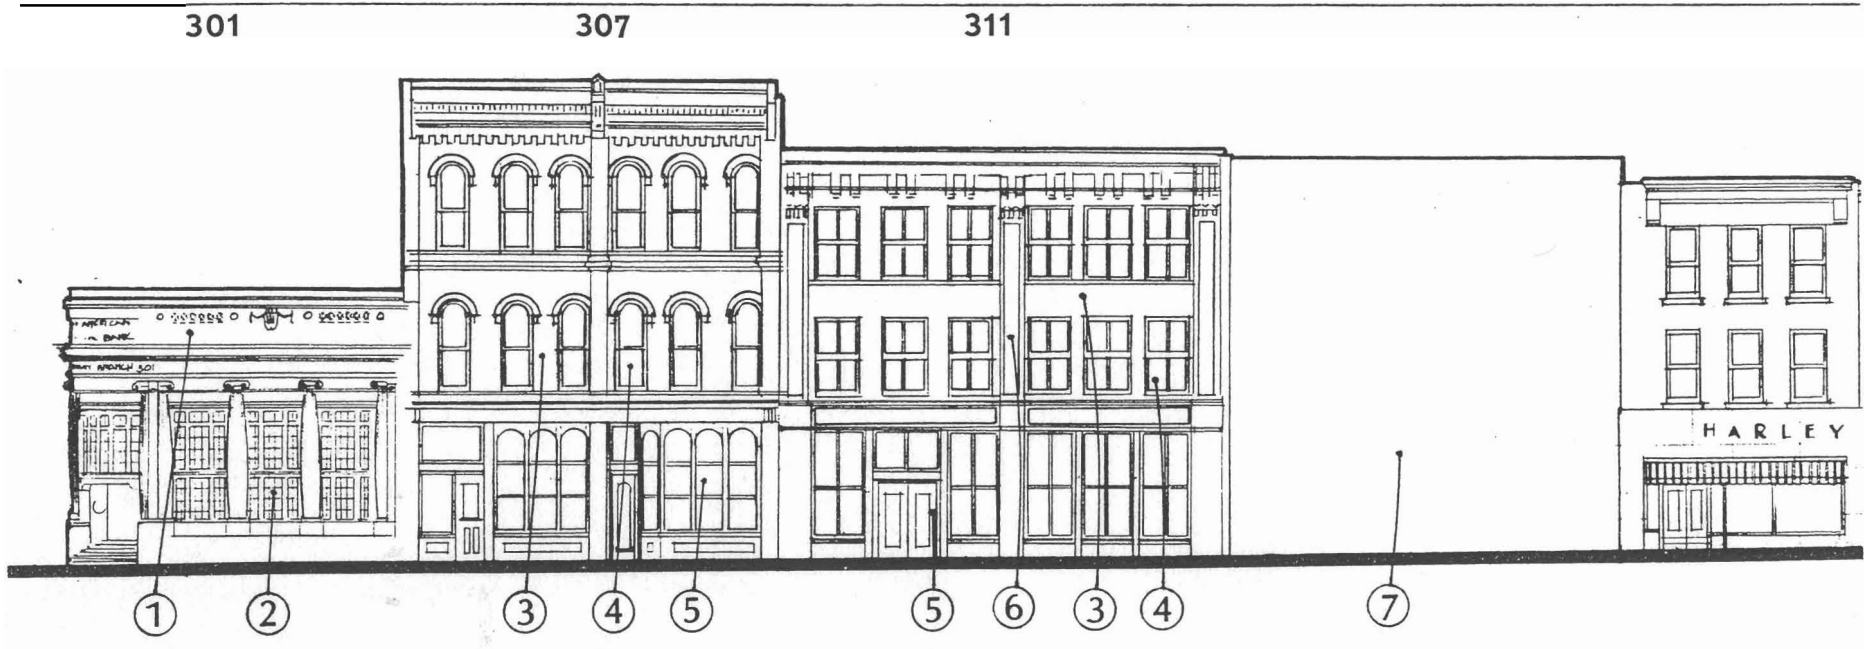
## 300 BLOCK, SOUTH SIDE

| ① Clean original facade according to guidelines | ③ Remove paint and repair brick as needed. | ⑤ Reconstruct historic storefront or install compatible contemporary storefront. | ⑦ Construct new building compatible in design with adjacent historic buildings. |
| ② Restore original windows | ④ Restore upper facade windows and remove paint from glass. | ⑥ Remove sign and consider installing new sign according to guidelines. | |

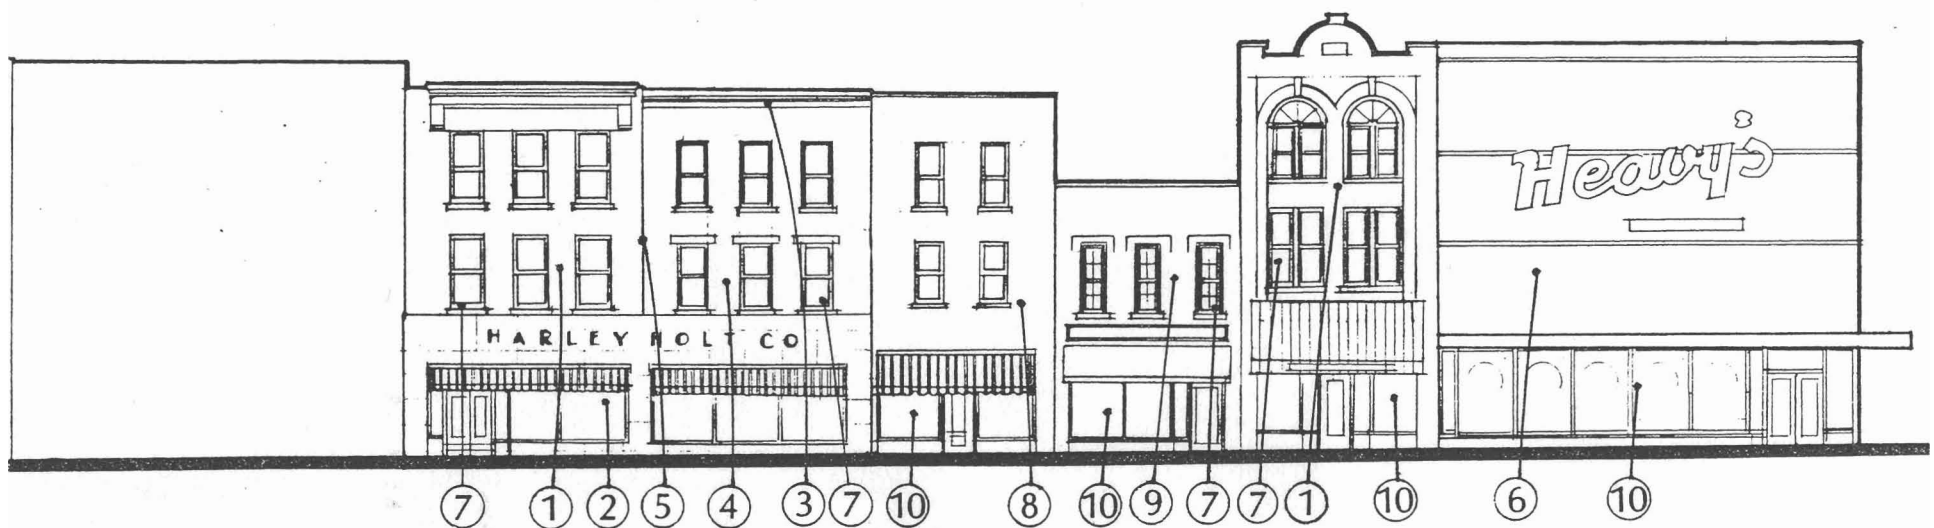
300 BLOCK, SOUTH SIDE cont.

| ① Remove paint and repair brick as needed. | ④ Repair original brick wall as necessary. | ⑦ Restore upper facade windows. | ⑨ Repair and tuckpoint brick wall as needed. |
| ③ Restore cornice. | ⑥ Remove false facade and restore upper facade. | | |

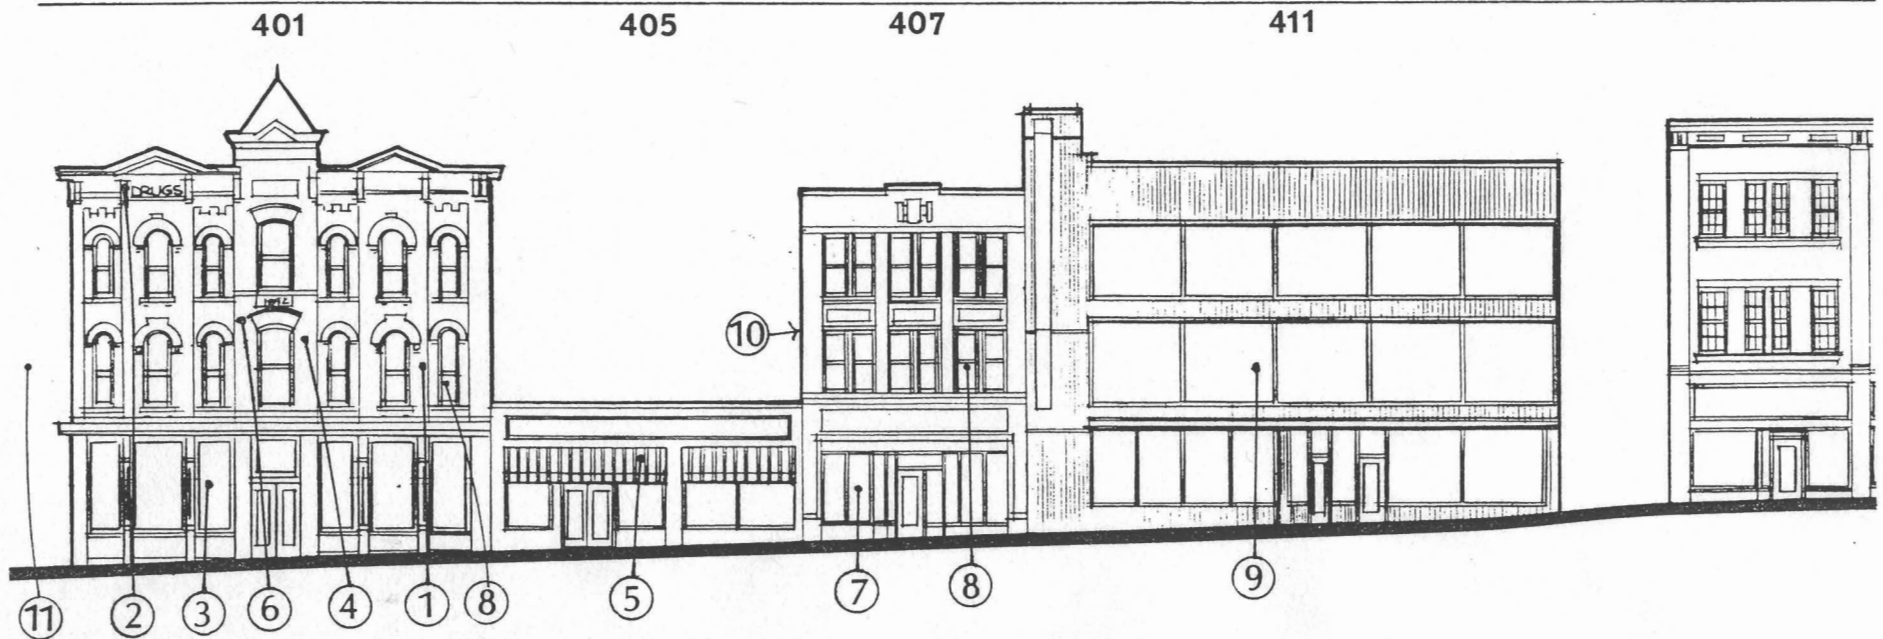
## 400 BLOCK, SOUTH SIDE

| ① Remove paint and repair brick as necessary. | ④ Repair structure and restore brick facade. | ⑥ Remove fire escape, if possible. | ⑨ Maintain in existing good condition with interesting window displays. |
| ② Restore original cornice. | ⑤ Install canvas awning and new sign as shown. | ⑦ Repair existing storefront or install compatible contemporary storefront. | ⑩ Maintain or restore painted sign at side of building. |
| ③ Reconstruct original storefronts or remove inappropriate elements and rehabilitate existing storefronts. | | ⑧ Restore upper facade windows. | ⑪ Remove projecting sign and install more appropriate signage according to sign guidelines. |

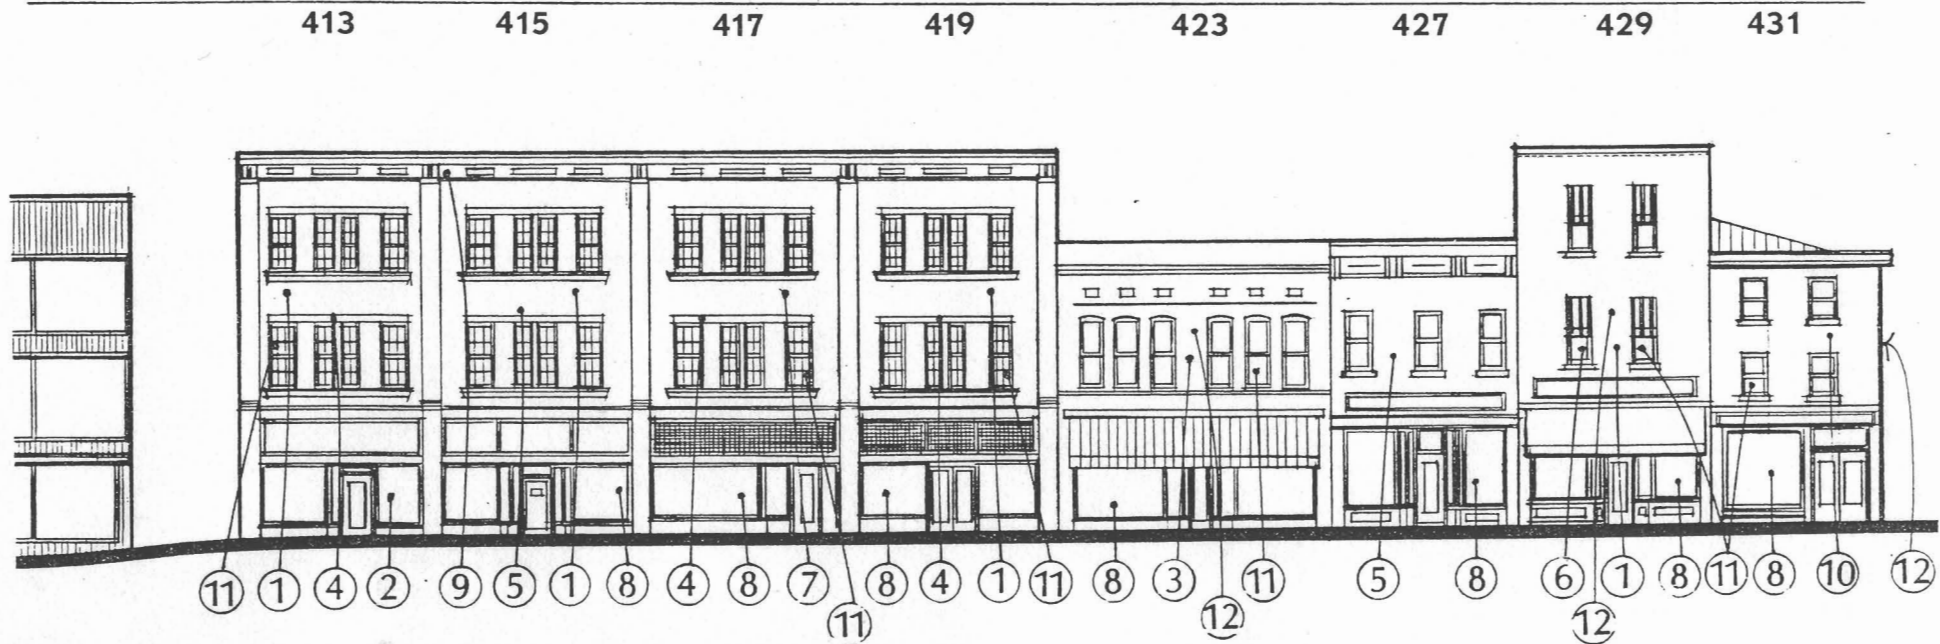
## 400 BLOCK, SOUTH SIDE cont.

| ① Paint facade with complementary colors to enhance detail. | ④ Repair wood sills and lintels as needed. | ⑦ Stabilize brick facade and repair as needed. | ⑩ Reconstruct brick wall to match original. |
| ③ Remove paint and repair brick as needed. | ⑥ Install awnings at upper facade windows. | ⑨ Reconstruct cornice to match original. | ⑫ Remove existing signage and install new sign at storefront according to sign guidelines. |

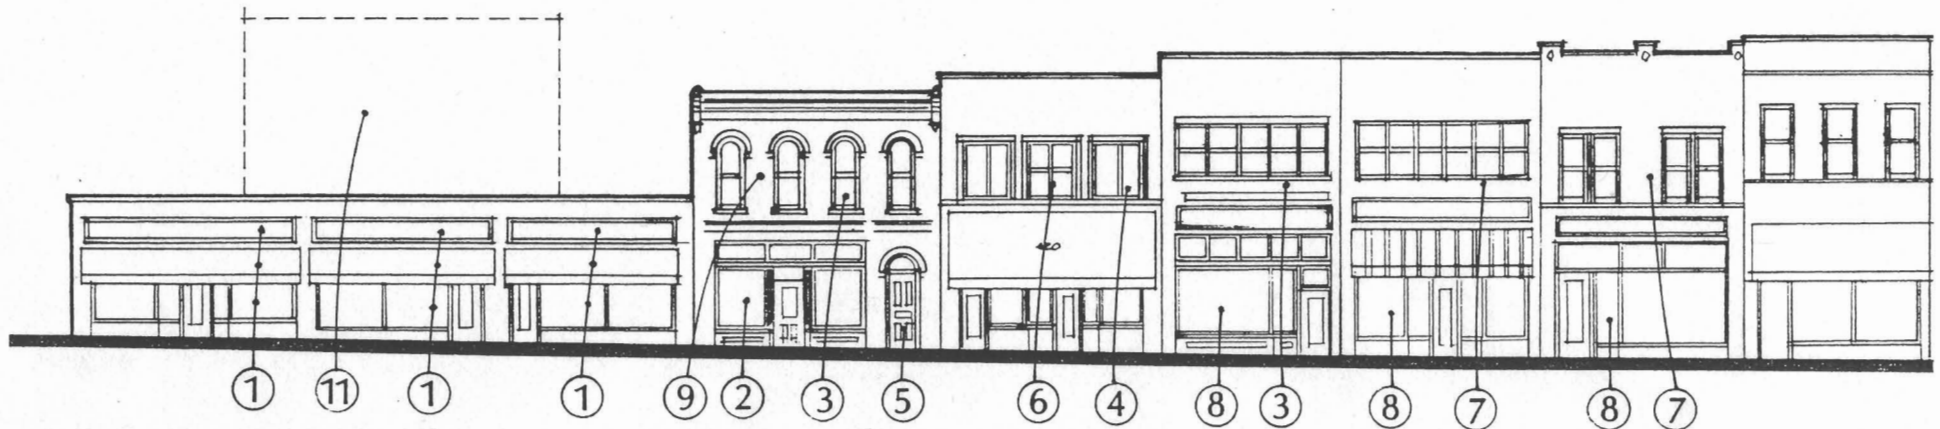
## 400 BLOCK, NORTH SIDE

| ③ Restore upper facade windows. | | ⑧ Reconstruct historic storefront or install compatible contemporary storefront. | ⑪ Remove billboard from top of building. |

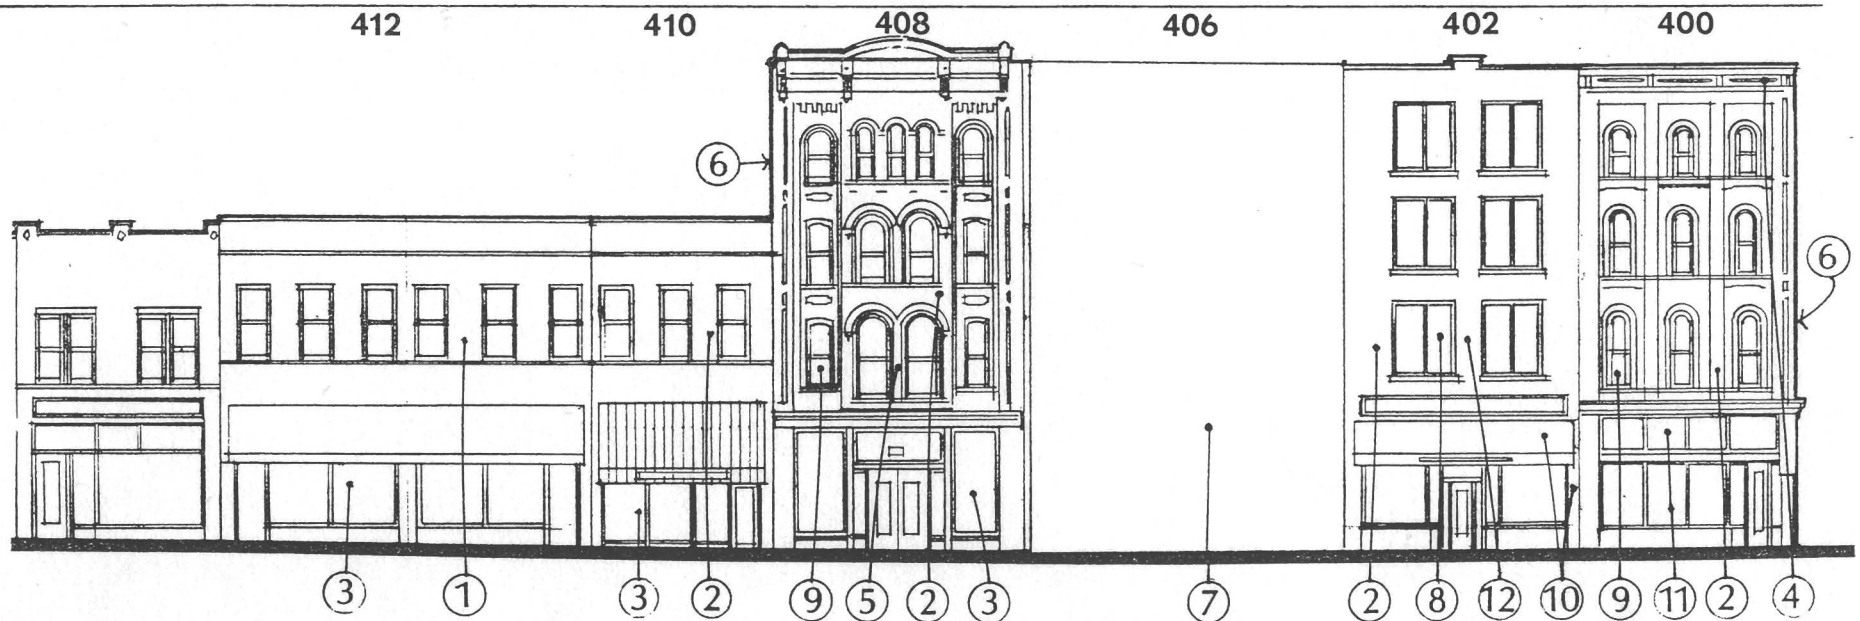
## 400 BLOCK, NORTH SIDE cont.

| ① Remove false facade and restore upper facade. | ④ Reconstruct cornice to match original. | ⑦ Construct new building compatible in design with adjacent historic structures. | ⑩ Restore brick storefront piers replace metal canopy with canvas awning. |
| ③ Reconstruct historic storefront or install compatible contemporary storefront; also consider installing a canvas awning. | ⑥ Maintain or restore painted sign on side of building. | ⑨ Restore upper facade windows. | ⑫ Consider restoring and retaining existing neon sign. |

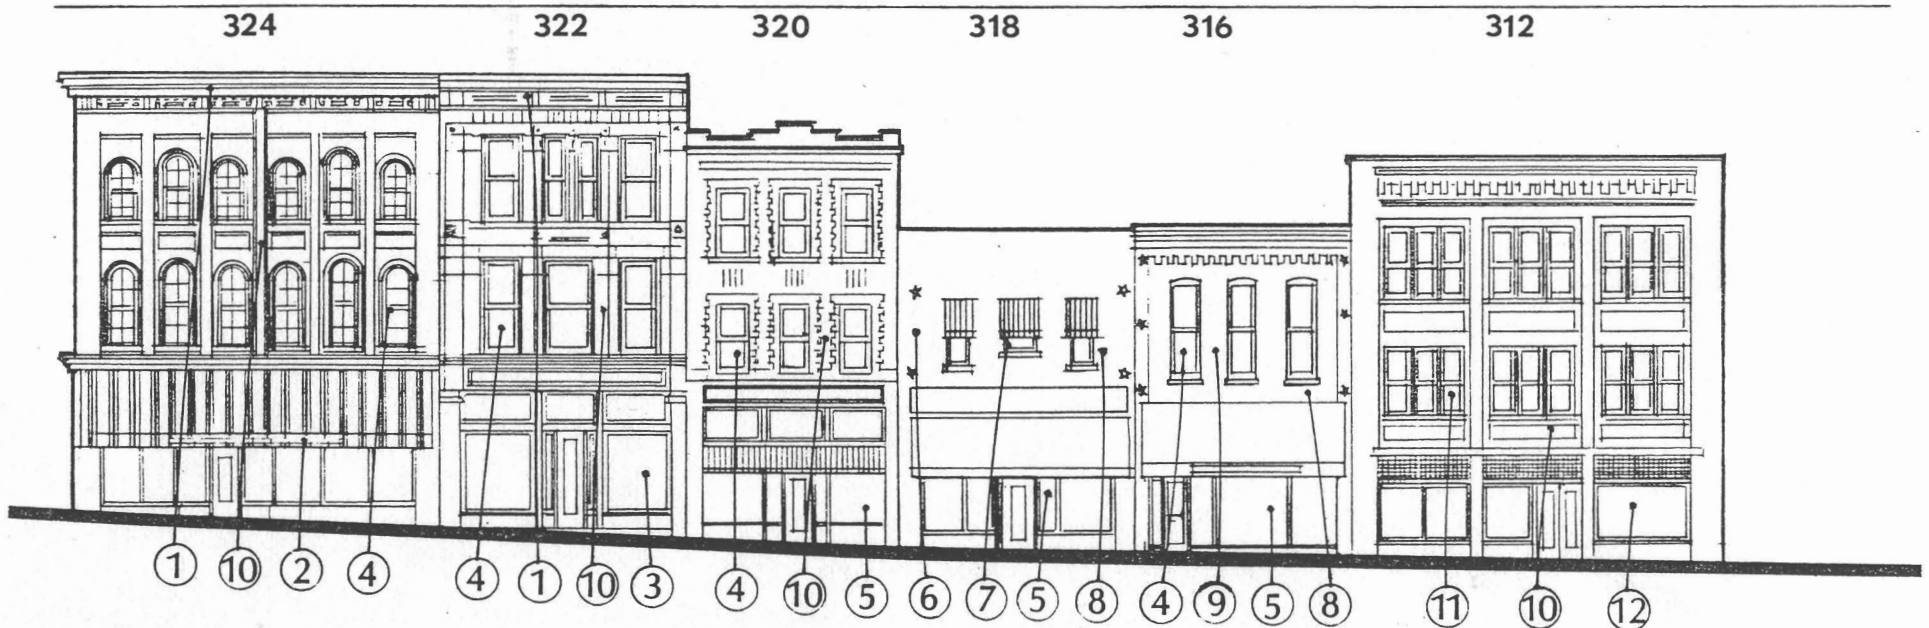
## 300 BLOCK, NORTH SIDE

| ① Reconstruct cornice to match original. | ④ Restore upper facade windows. | ⑦ Install canvas awnings at upper facade windows. | ⑩ Remove paint and repair brick as necessary. |
| ③ Reconstruct storefront with existing historic columns. | ⑥ Locate projecting sign at edge of building over storefront pair. | ⑨ Remove sign. | ⑫ Restore historic storefront. |

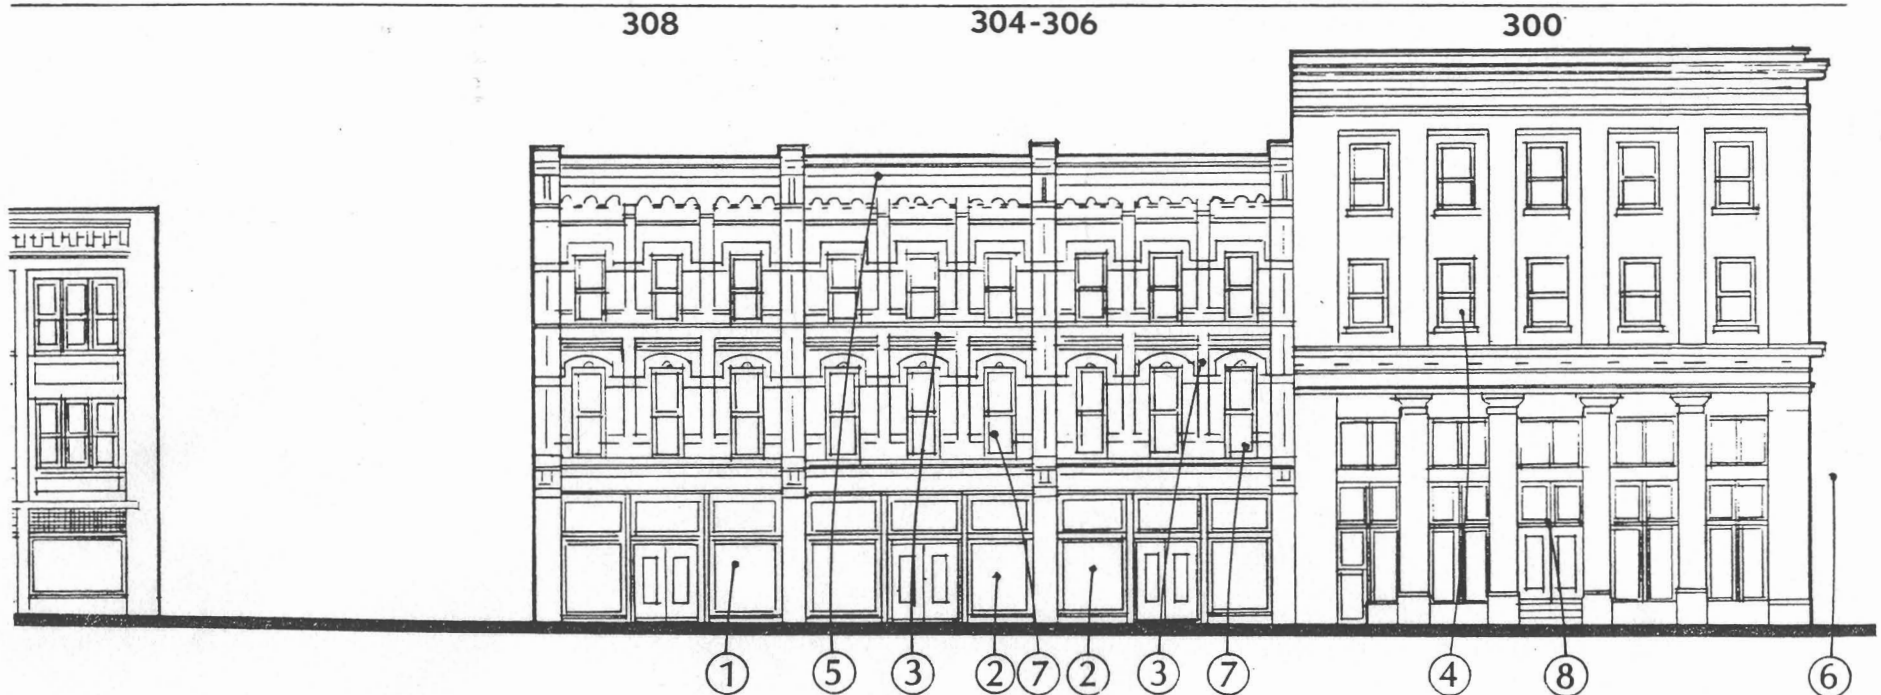
## 300 BLOCK, NORTH SIDE cont.

| ① Complete restoration of historic storefront. | ③ Remove paint and repair brick as necessary. | ⑤ Restore original cornice to match adjacent buildings. | ⑦ Restore upper facade windows. |
| ② Reconstruct storefront to match adjacent historic storefront or install compatible contemporary storefront. | ④ Repair and repaint windows at upper floors and ground level. | ⑥ Remove sign. | ⑧ Remove aluminum canopy. |

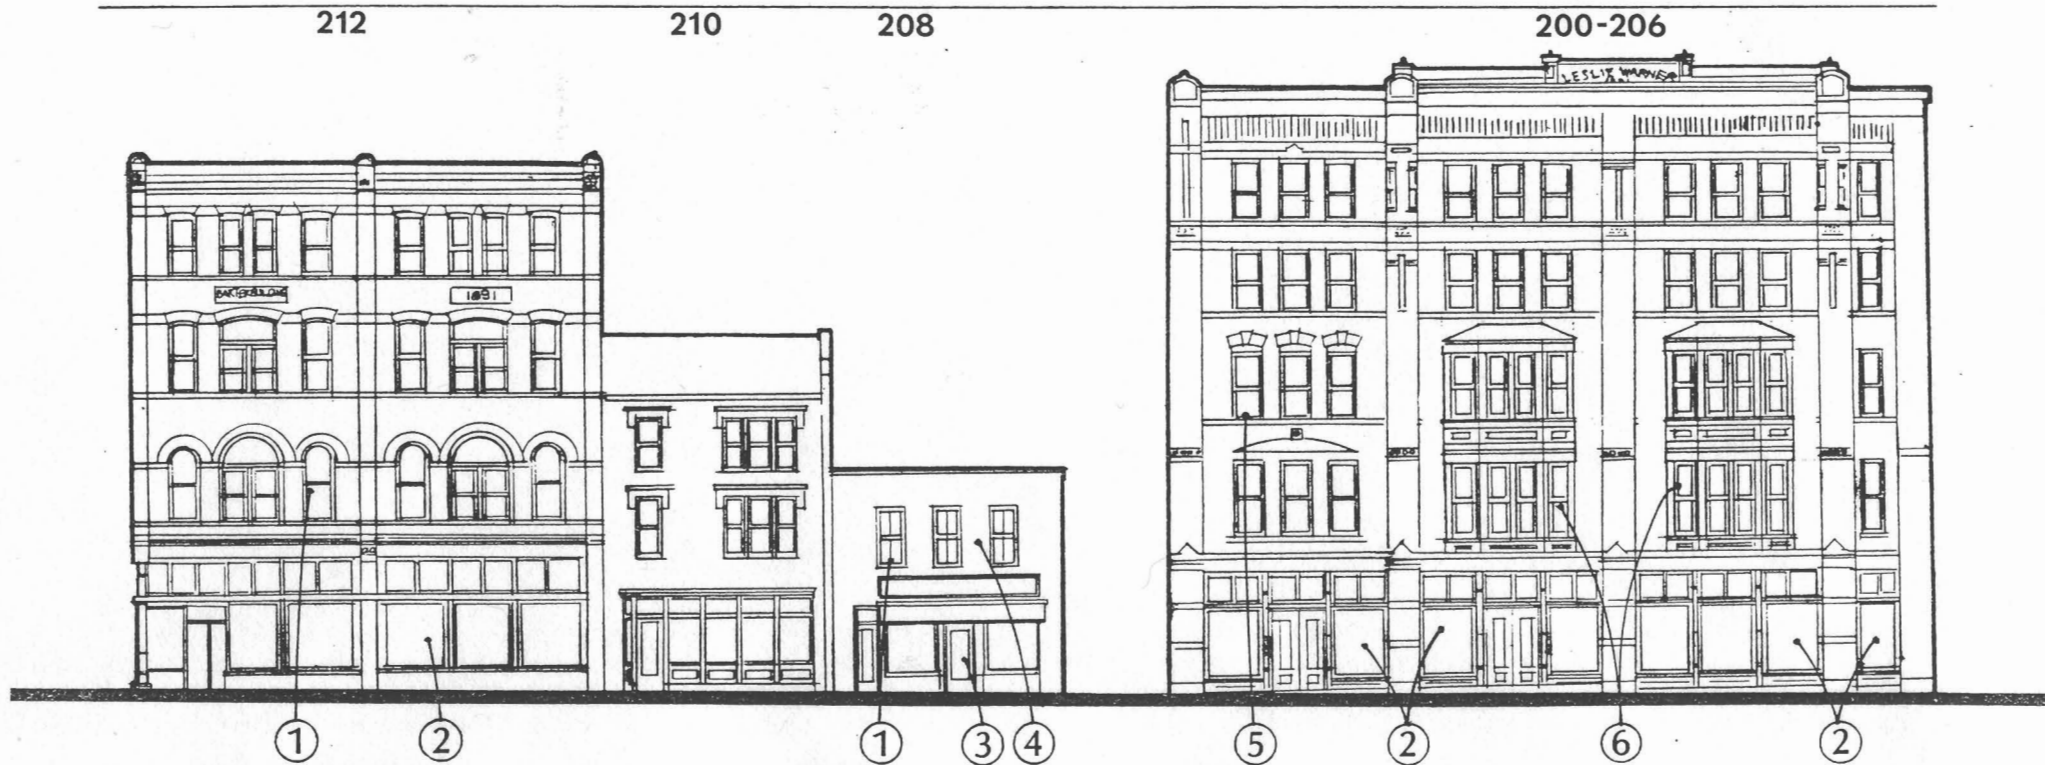
200 BLOCK, NORTH SIDE

- ① Restore windows at upper facade.
- ② Repair existing storefront.

- ③ Install new storefront and signage.
- ④ Remove existing sign and install new sign according to signage guidelines.

- ⑤ Remove fire escape, if possible.

- ⑥ Restore storefront to original design.

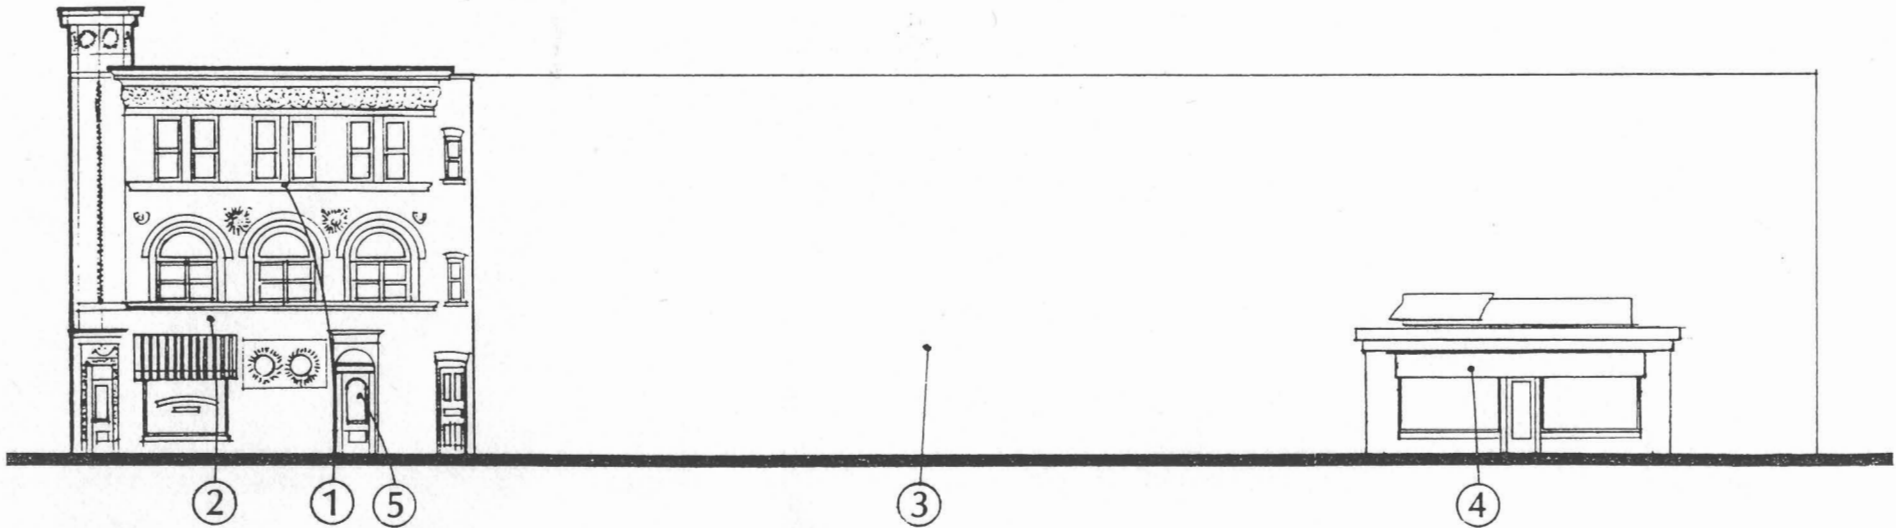
## 100 BLOCK, NORTH SIDE

- ① Remove fire escape when adequate fire exits are provided in conjunction with adjacent new construction
- ② Remove paint from brick and terra cotta.
- ③ Construct new building compatible in design with adjacent historic buildings.
- ④ Maintain existing building in good condition and consider replacing aluminum canopy with a canvas awning.
- ⑤ Reconstruct historic doorway in original location.
